# EXISTING FACILITIES NEEDS ASSESSMENT FOR The South Padre Island Convention Center

For the  
City of South Padre Island, Texas  
June 1, 2012

rofa  
architects

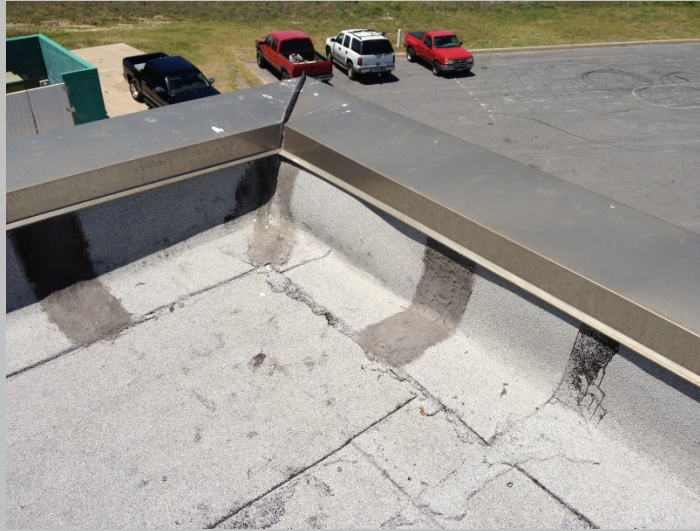
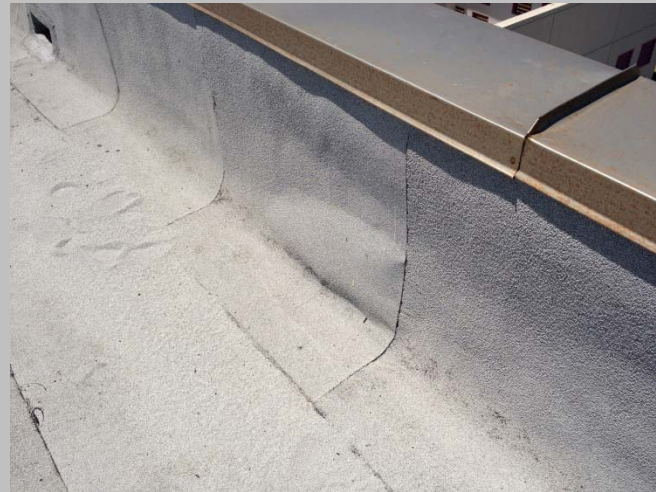
After 4 years of wear, the new roof is holding up well. As shown in the photos below, there are some signs of membrane delaminating and water ponding. This is covered by the roof warranty and efforts should be made to contact the roof manufacturer to remedy these conditions.

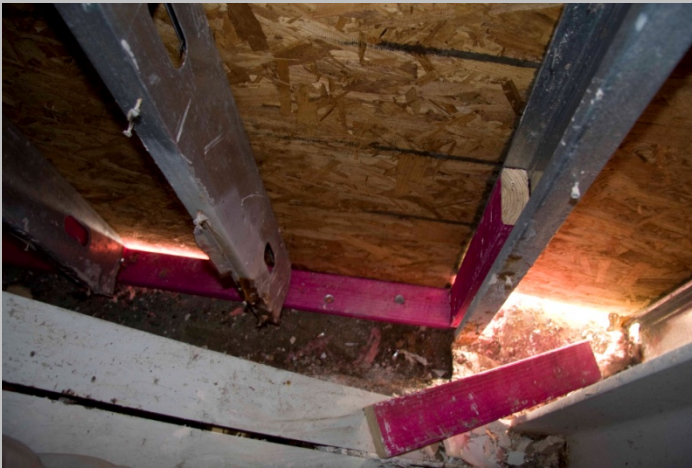
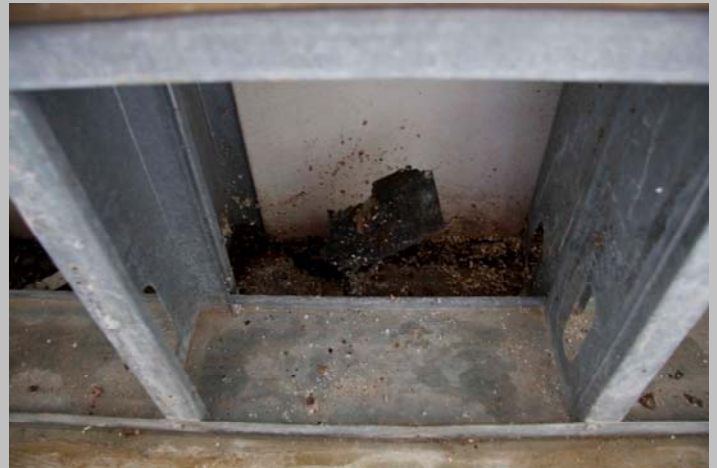
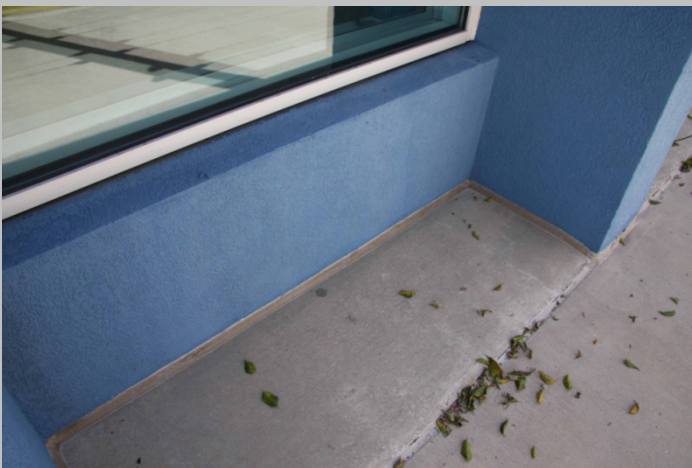
Our observations led us to believe that the exterior walls of the facility lack an important vapor or water barrier membrane(s) within the wall. Pictures show this deficiency in the wall that collapsed and other perimeter walls. All these wall show significant corrosion to the vertical metal studs and bottom track. In some cases, the bottom track has completely corroded and is nothing more than metal dust. No vapor barrier, base flashing, or weep hole are visible. These are very important components that belong in the cavity of the wall for they allow the intruding moisture a way to weep out of the wall. It's very possible that more walls will collapse if you do not repair the bottoms of these exterior metal stud walls. Furthermore, we recommend installing vapor barriers, base flashing and weep holes. This will be a very intrusive repair.

It is our recommendation that the highest priority in any renovation effort should be to replace all exterior wall studs with new stud walls or concrete block. In lieu of the existing EFIS system, a convention stucco exterior should be installed. In this way, the wall would have an integral vapor barrier that work in concert with through and base wall flashing. Weep holes at the bottom of the wall will ensure that any moisture is wicked out of the walls.

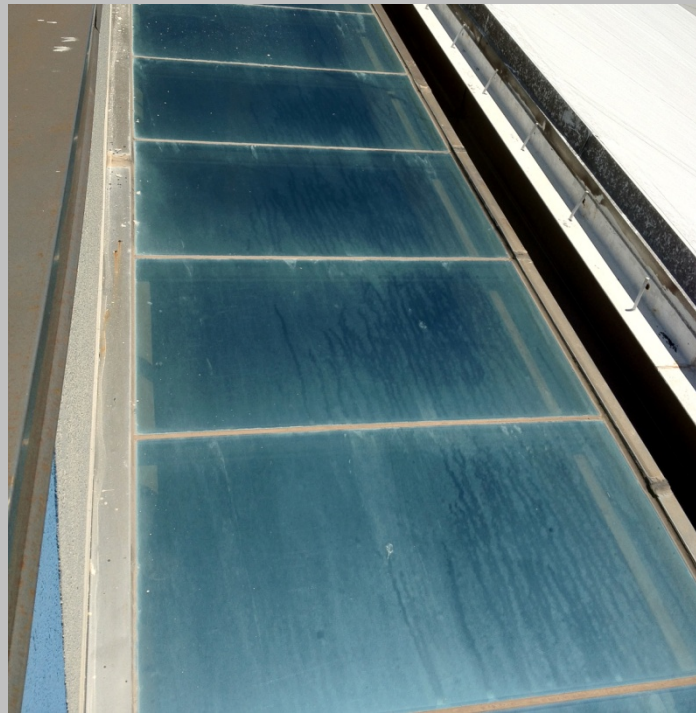
The sky light at the main lobby has and does leak. Visual inspection shows wear at the gaskets. Replacing all gaskets should illuminate the problem. As reported by Convention Center staff, this is a constant problem.

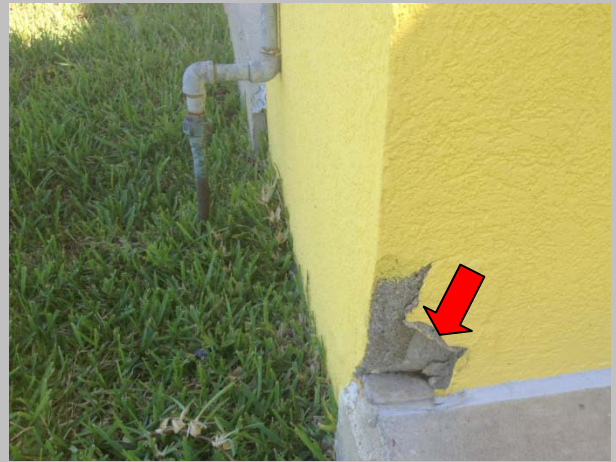
1. Some punctures present in the exterior EIFS. (Photo #1)
2. Column base cracks present at west side walkway. (Photo #2)
3. Some evidence of movement visible in the form of cracks and separation of expansion joints at the west side walkway. (Photo #3)
4. Blistering of the roof cap sheet was observed at the base of flashing in several areas. (Photo #4)
5. Secondary drainage of the roof system is not present near the entrance of the Exhibit Storage area. (Photo #5)
6. Loss of fasteners and moderate to severe corrosion was observed at the support of the chiller unit located within the exterior mechanical room. Moderate corrosion was observed at some mechanical units. (Photo #6 and #7)

**Photo #2** Column base crack at west side walkway.

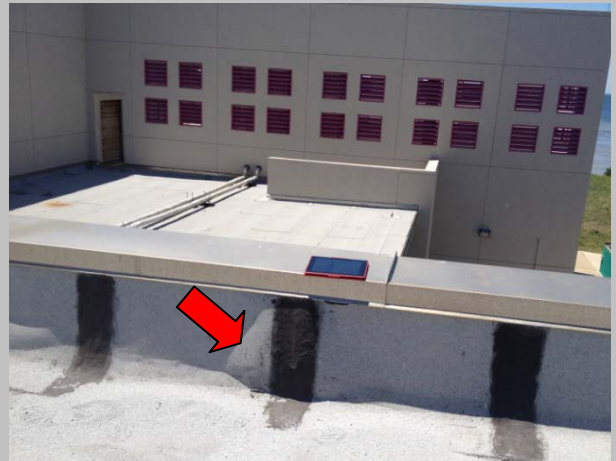
Generally, the roof system is in good condition with isolated areas of blistering of the cap sheet and some evidence of ponding along the central canopy/main lobby area. The roof near the Exhibit Storage entrance area does not have a secondary drainage system.

**Photo #4** Blistering of cap sheet at base of flashing near Exhibit Hall and Loading Area.

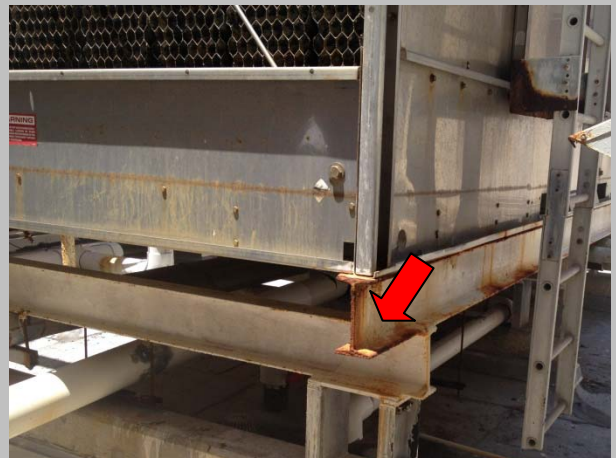
The exterior steel members used to frame the central canopy have experienced moderate corrosion. The cooling tower unit support at the exterior mechanical area has undergone moderate to severe corrosion and loss of fasteners. Moderate corrosion is used to describe larger scale chipping and delamination of coatings, minor volume expansion and/or minor delamination of the base metal. Severe corrosion is used to describe larger scale volume expansion, delamination of the base metal and/or through-section loss of the base metal.

**Photo #6** Moderate to severe corrosion at support of mechanical unit located at the Exterior Mechanical Area.

1. Replace the cooling tower unit support at the exterior mechanical area.
2. Replace steel frame supports at central canopy/main lobby that have undergone more severe corrosion.
3. Replace or repair exterior wall metal studs and bottom tracks that have experienced severe corrosion and minimize the potential for future corrosion by implementing an adequate moisture protection system.
4. Replace the aluminum windows at the clerestory windows located along the central canopy/main lobby area.
5. Replace all storefronts, aluminum windows, glazing at skylight and clerestory, and louvers with those meeting the requirements set forth in IBC 2006.

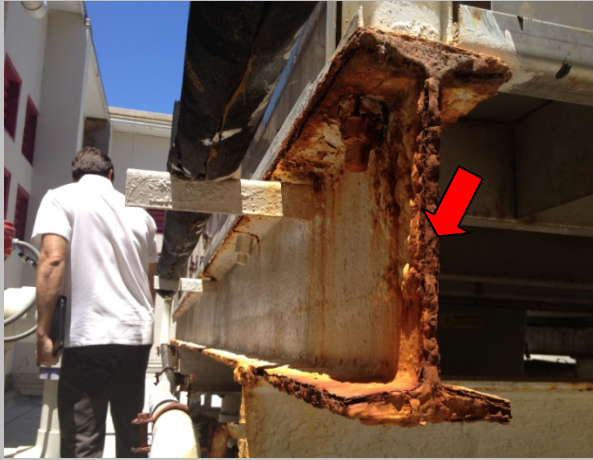
**Photo #7** Loss of fasteners and sever corrosion of support of mechanical unit located at the Exterior Mechanical Room.

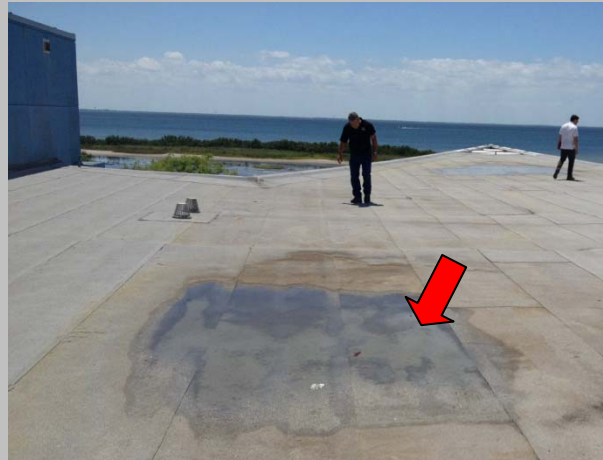
8. Evidence of ponding is present at various locations of the central canopy/main lobby. (Photo #9)
9. Degradation of sheet rock and metal studs observed below door to cooling tower. (Photo #10)

**Photo #9** Evidence of ponding at central canopy/main lobby area.

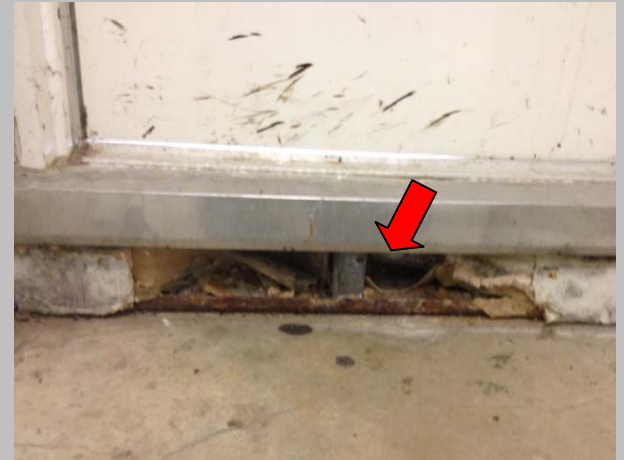
**Photo #10** Degradation of sheet rock and metal studs below door to cooling tower.

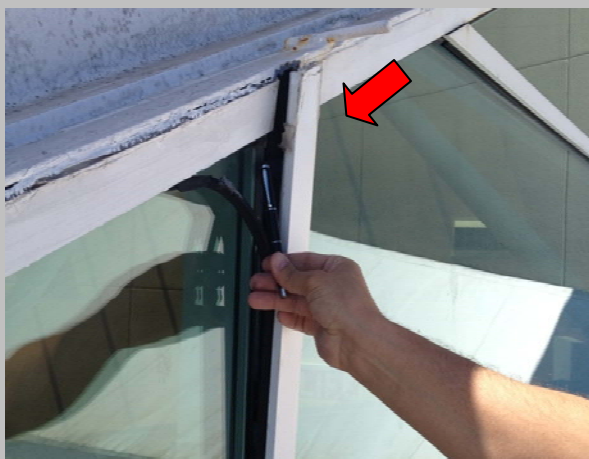
10. Failed sealant and damaged mullion was observed at the aluminum window assembly at the canopy/main lobby clerestory windows. The rubber compression gaskets appear weathered and may lead to water infiltration in the future. (Photo # 11)

**Photo #11** Failure of sealant and loss of mullion at aluminum window at central canopy/main lobby area clerestory windows.

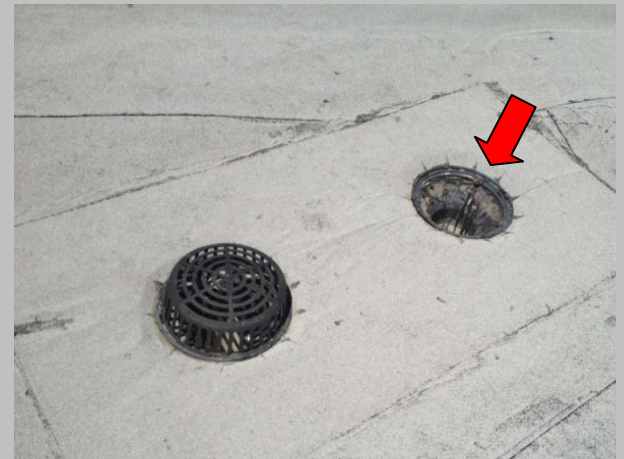
**Photo #12** Secondary drain dome missing.

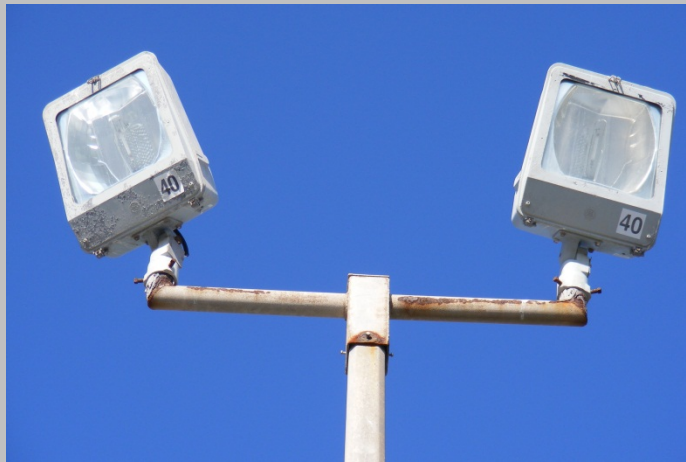
The parking lot lighting consists of metal halide fixtures mounted on steel cross arms and secured to concrete poles. The paint is peeling from the light fixtures and the cross arms are rusting. The concrete poles appear to be in operable condition.

All exterior panelboards and light fixtures are experiencing severe deterioration due to the corrosive environment. All exterior panelboards should be replaced with fiberglass enclosures to avoid premature failures. The parking lot lighting fixtures and supports should be replaced and all concrete poles missing hand-hole covers should be provided with appropriate covers. All landscape in-ground lighting fixtures and building-mounted light fixtures should all be replaced due to their weathered and rusted condition. The security light fixtures mounted on the wooden should be replaced and provided with watertight connectors. All steel disconnect switches and mounting hardware serving mechanical rooftop equipment should be replaced with stainless steel disconnect switches. There are some disconnect switches that have recently been replaced with new fiber glass enclosures. We recommend that all mounting hardware be replaced with stainless steel hardware.

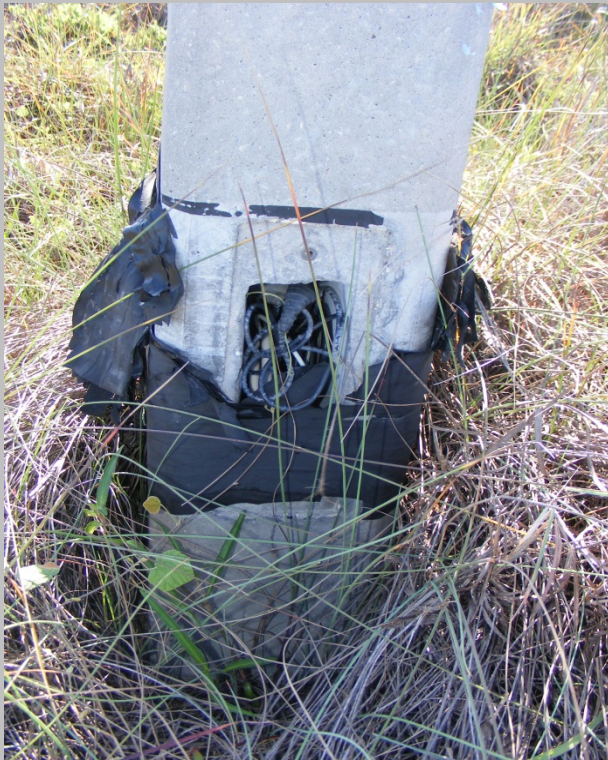
Hand-hole covers are also missing at the base of some concrete poles, exposing the lighting branch conductors.

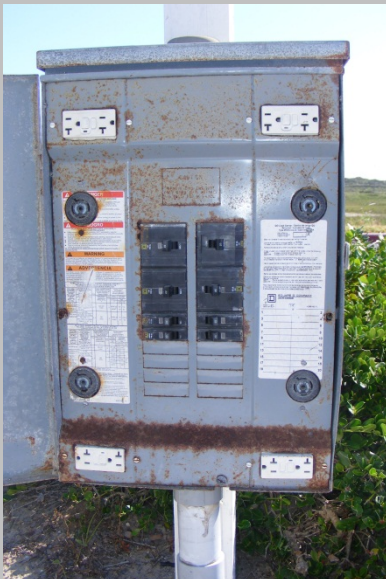
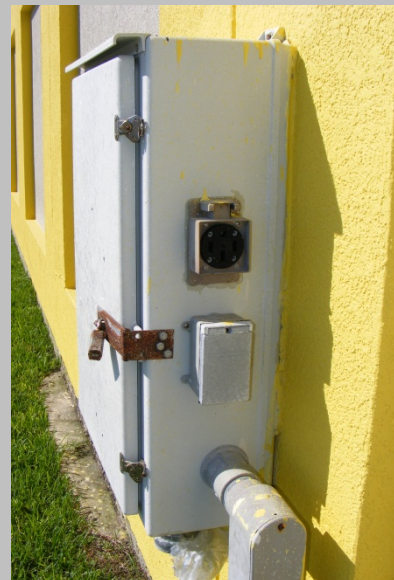
The exterior road show panelboard located in the parking lot closest to the convention center is rusted. The panelboard that is secured to the north side of the building is also rusted.

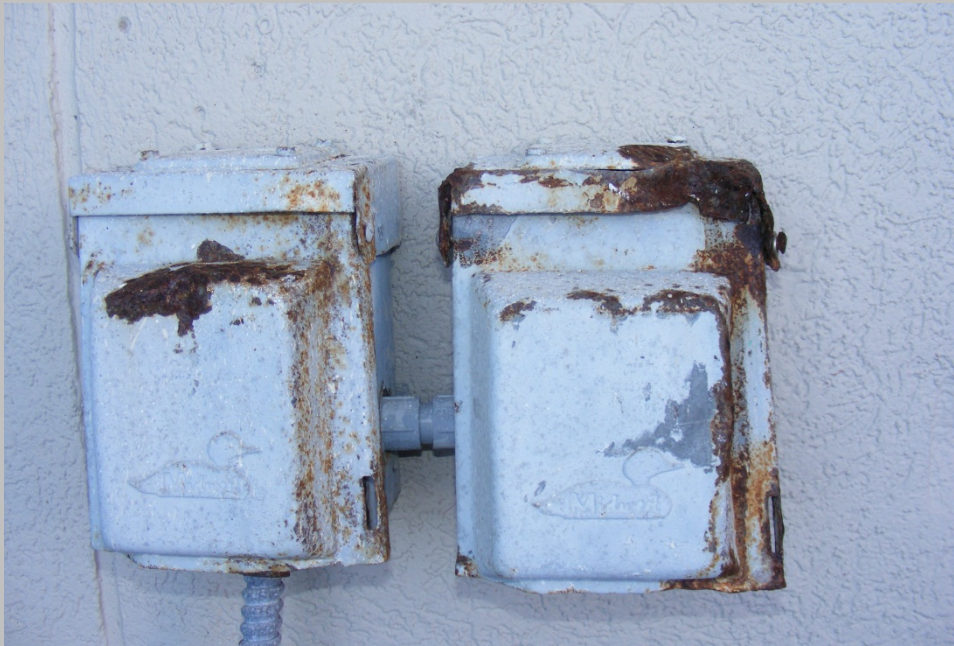
The NEMA 3R disconnect switches located in the loading dock are rusted and weathered.

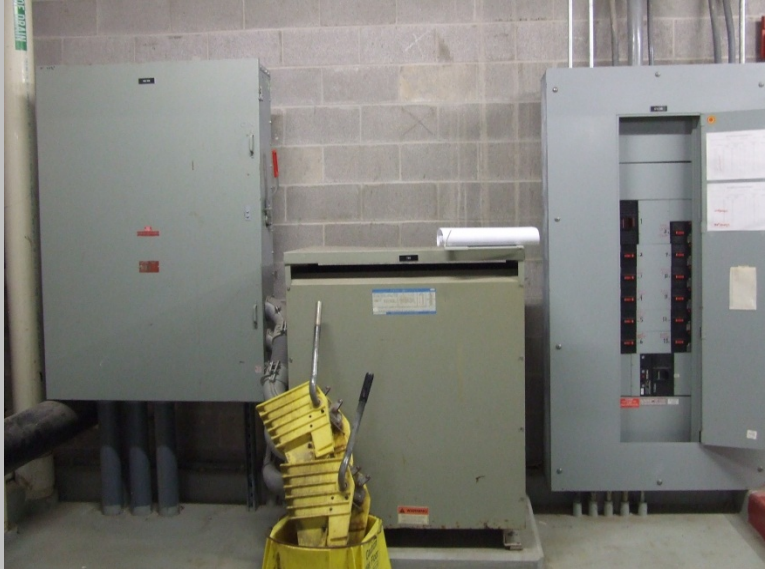
The electrical switchgear's manufacturer is General Electric (GE). The interior distribution panelboards and dry-type transformers appear to be in good condition. Dry-type transformers are approximately 20 years old, and are not as efficient per today's industry standards. Some panelboard directories are missing and the circuit breaker loads are not properly identified.

Provide new load description labeling on all distribution and branch panelboards. Replace all dry-type transformers with new efficient, NEMA TP-1, style transformers. All electrical connections in distribution and branch circuit panelboards should be re-torque per the manufacturer's recommendations. In the main electrical room, the main switchboard shall be inspected for rust on internal components. If rust is detected, the switchboard should be replaced. The interior components of the electrical equipment in secondary electrical rooms should also be inspected for rust. Electrical rooms should be properly sealed and air conditioned in order to minimize exposure to the outdoor environment.

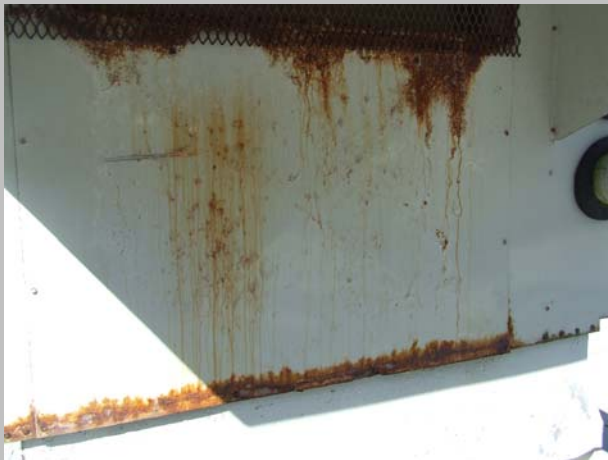
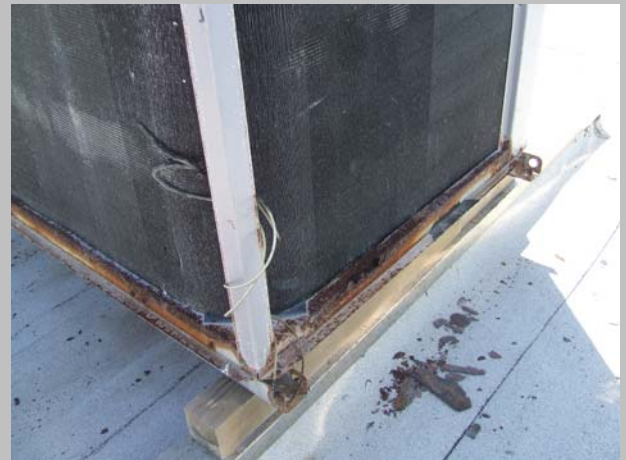
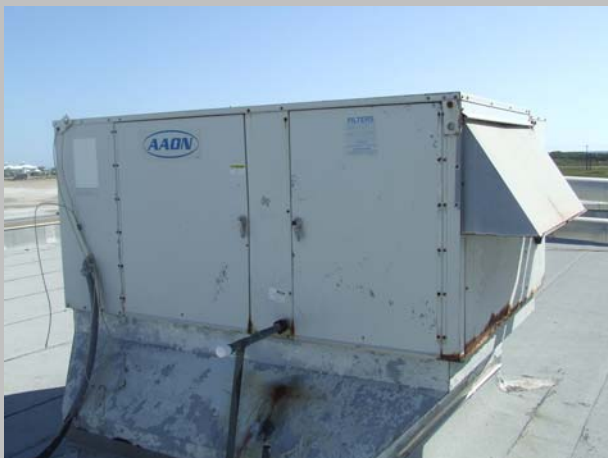
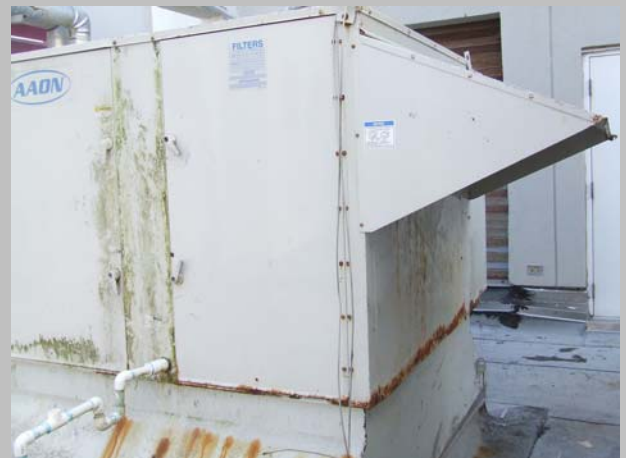
3. All of the rooftop equipment and condensing units have a remaining useful life of 5 years or less due to corrosion.
