Queen Isabella Memorial Causeway Structural Repairs

CSJ: 0031-04-065

Project Fact Sheet

QUEEN ISABELLA MEMORIAL CAUSEWAY Condition and Service Life Assessment

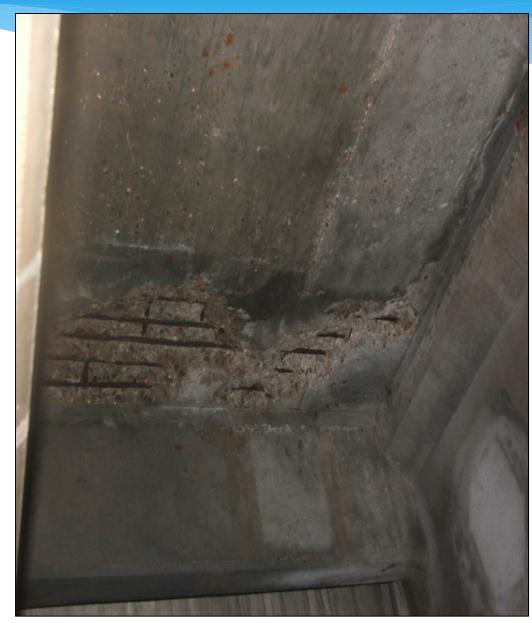
Span #1 WB Underside Bridge Deck Spalled concrete with exposed reinforcement.

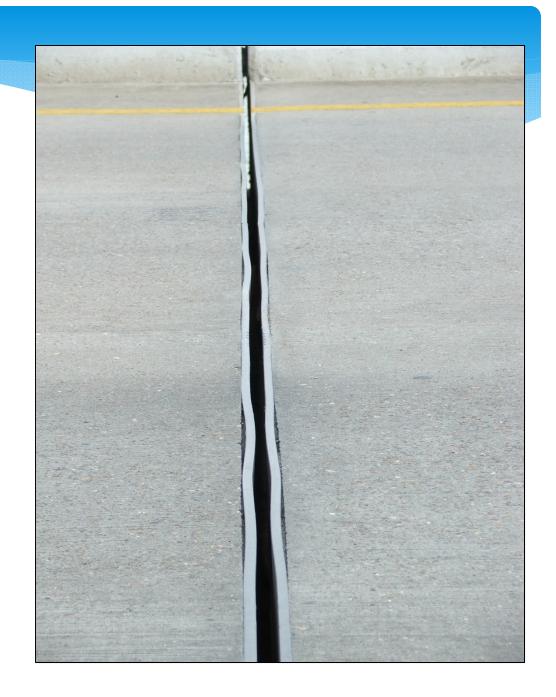
Armor Joint Throughout Bridge Plate deformation at anchor stud locations.

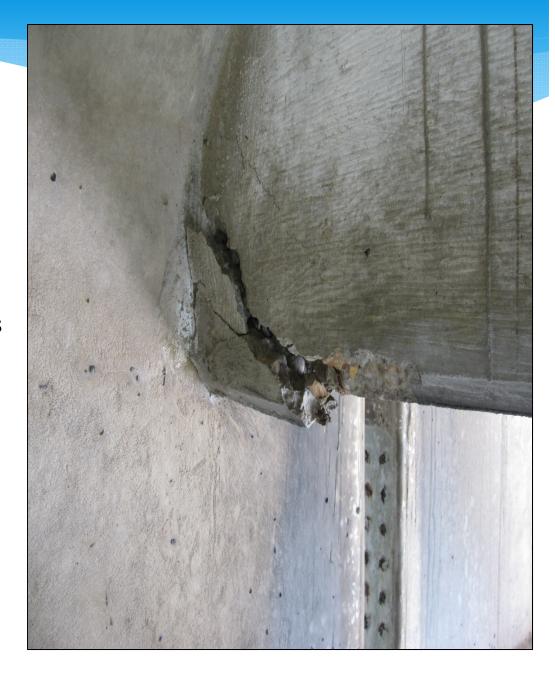
End Diaphram – Various Locations Cracked diaphram with exposed reinforcement.

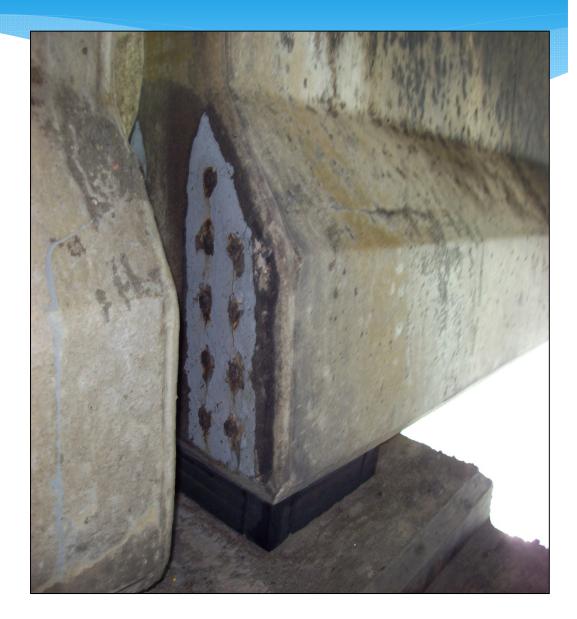
Beam End at Various Locations
Deteriorated epoxy coating and
exposed/corroded strands.

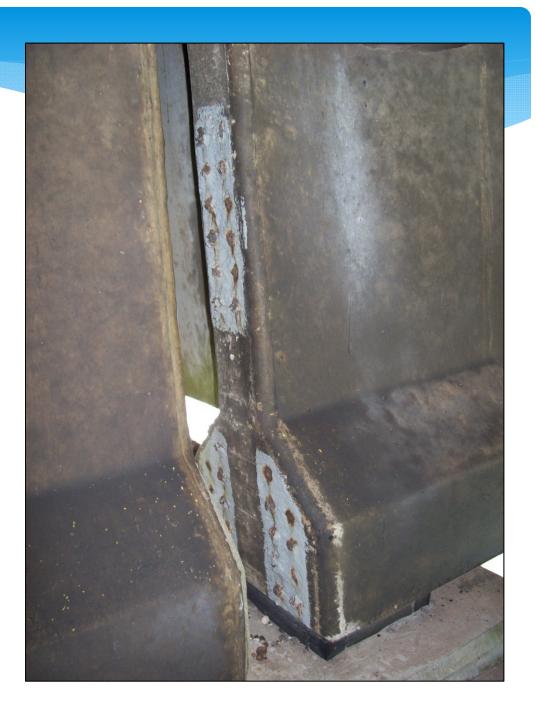
Beam End at Various Locations
Deteriorated epoxy coating and
exposed/corroded strands.

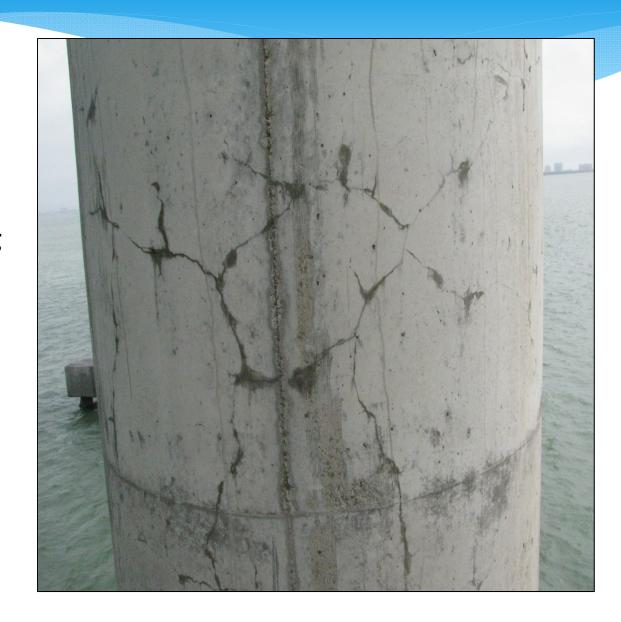
Bent #26 Cracked Column Minor map cracking along column.

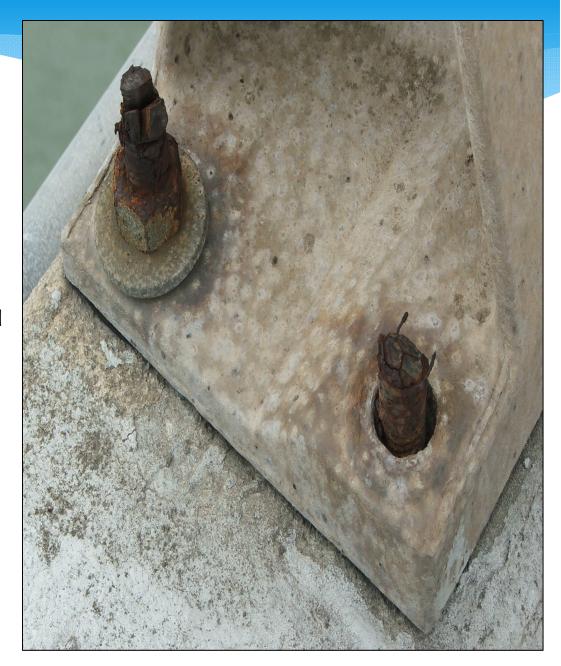
Existing Rail Connection - Typical Existing anchor bolts and hardware severely corroded.

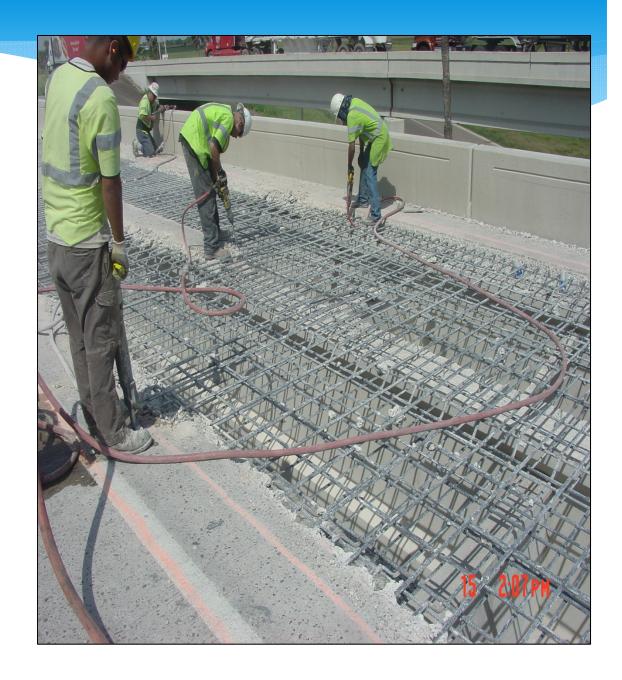
US 281 SBML @ BUS 281 Existing deck removal

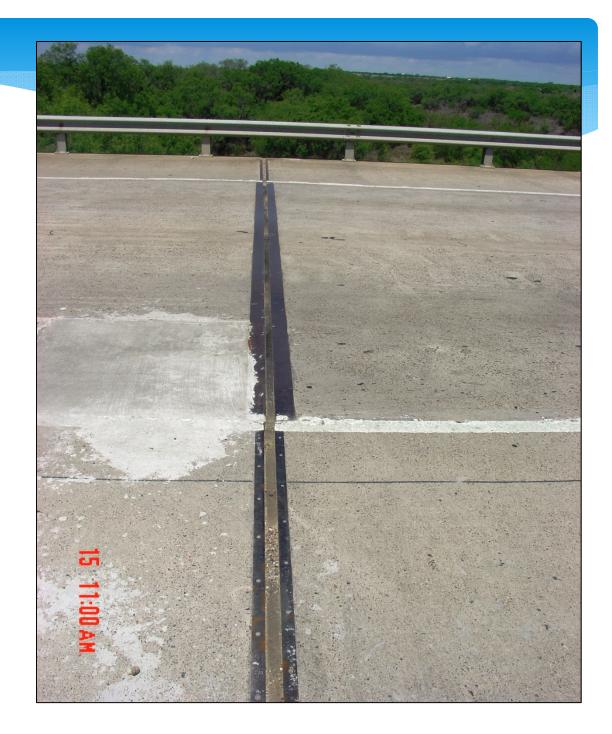
US 83 @ Arroyo Dolores Completed deck repair and cleaning and sealing joint.

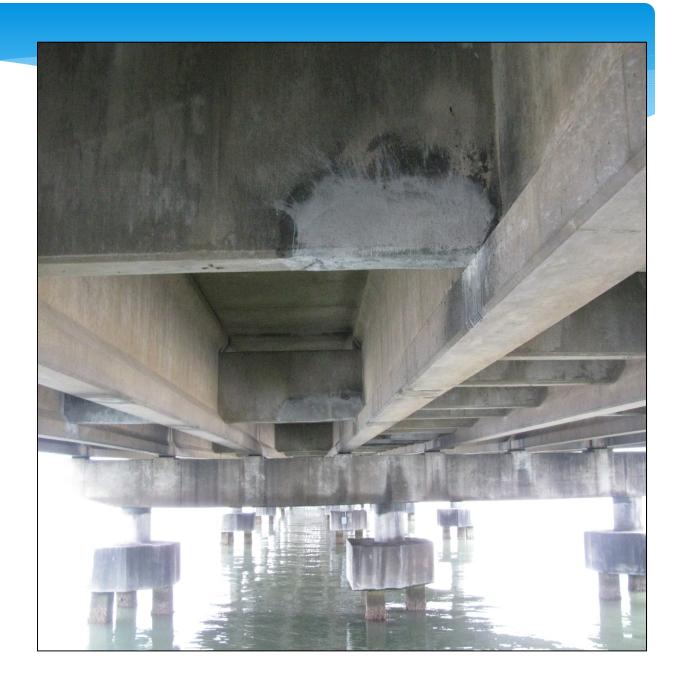
Completed Concrete Structure Repairs (Diaphrams)

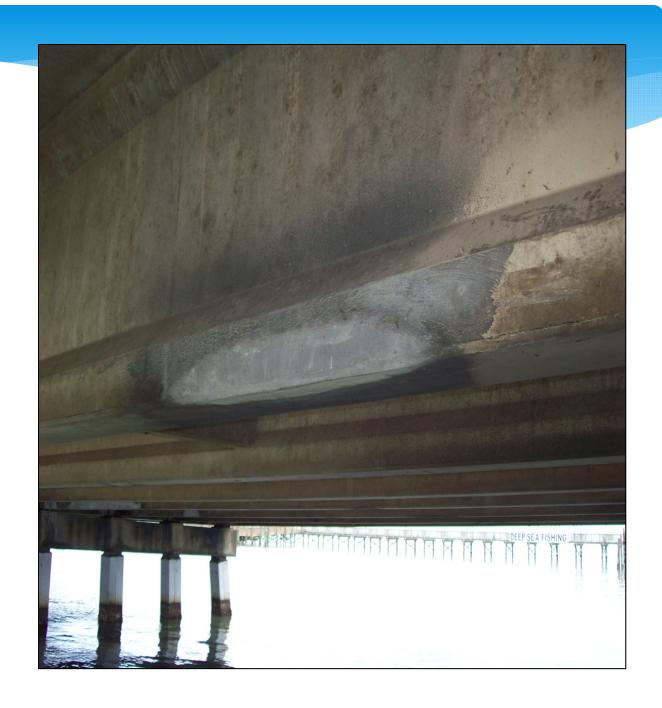
Completed Concrete Structure Repairs (Beam)

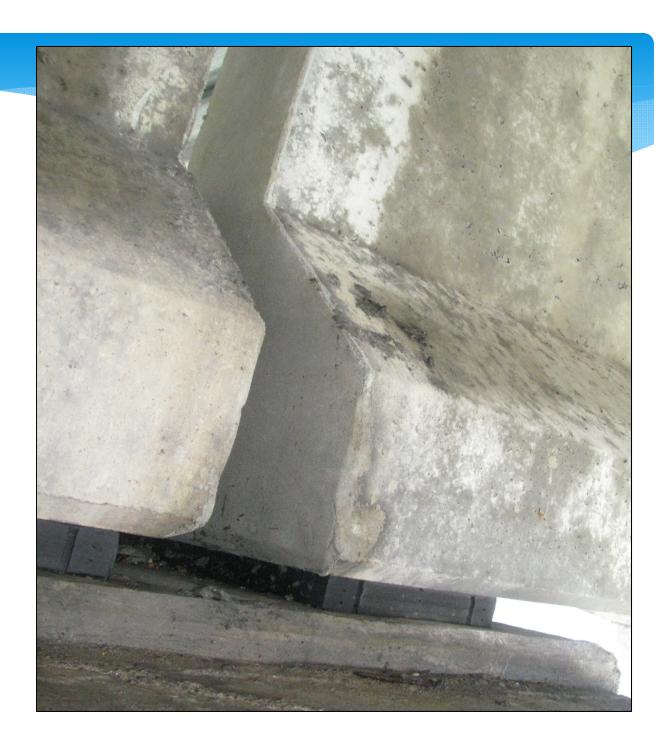
Protective Beam End Pre-Stressing strands covered.
