## South Padre Island Beach and Dune Assessment Project

### March 2021 Progress Update

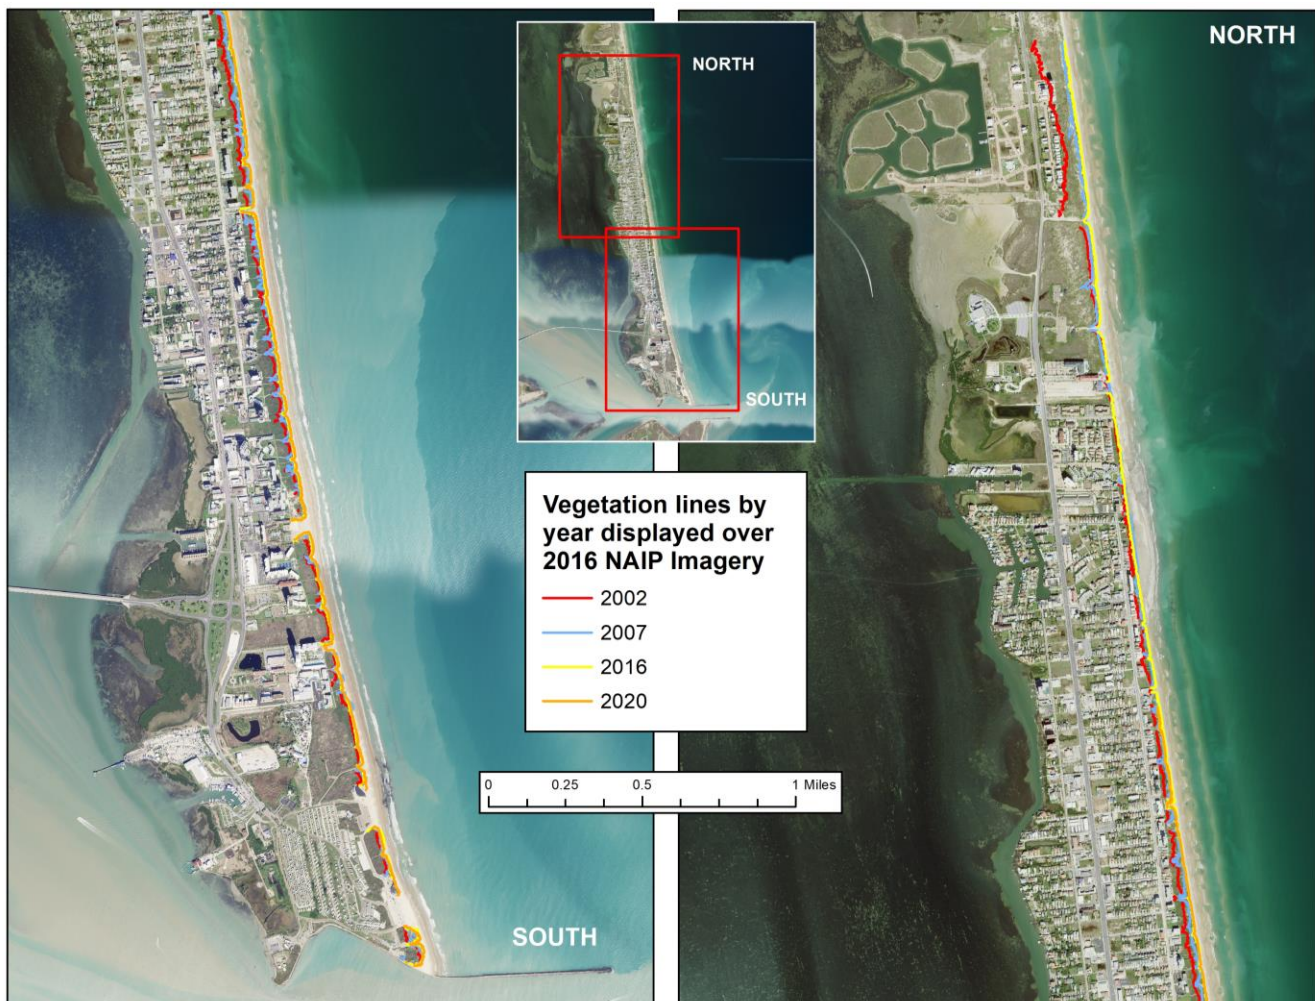
Figure 5. SPI study area showing the vegetation lines from 2002 – 2020. Note the 2020 line only covers the southern half of the study area due to limited coverage of the 2020 aerial imagery.

Vegetation lines were digitized from 2002, 2007, 2016, 2020 from available aerial photography (Figure 5). The 2020 line only extends for approximately the southern half of the study area from Brazos Santiago Pass to E. Aries Dr. due to the limited extent of the aerial imagery from 2020. The remaining three dates cover the entirety of SPI, for a time series of 14 years. In 2002, the vegetation line is consistently landward as compared to the later years, thus the vegetated dune area is much narrower and closer to the building line than in future years. In some locations, for example the section of coast from the Seabreeze Beach Resort (E. Carolyn Drive) to the Inverness Condos (Coronado Dr.), the vegetation line is right up against the buildings or nonexistent (Figure 6). Between 2002 and 2007, the vegetation line propagated significantly seaward, resulting in a more robust, wider vegetated dune system. The typical widening of the vegetated dunes from 2002-2007 was approximately 35 feet.

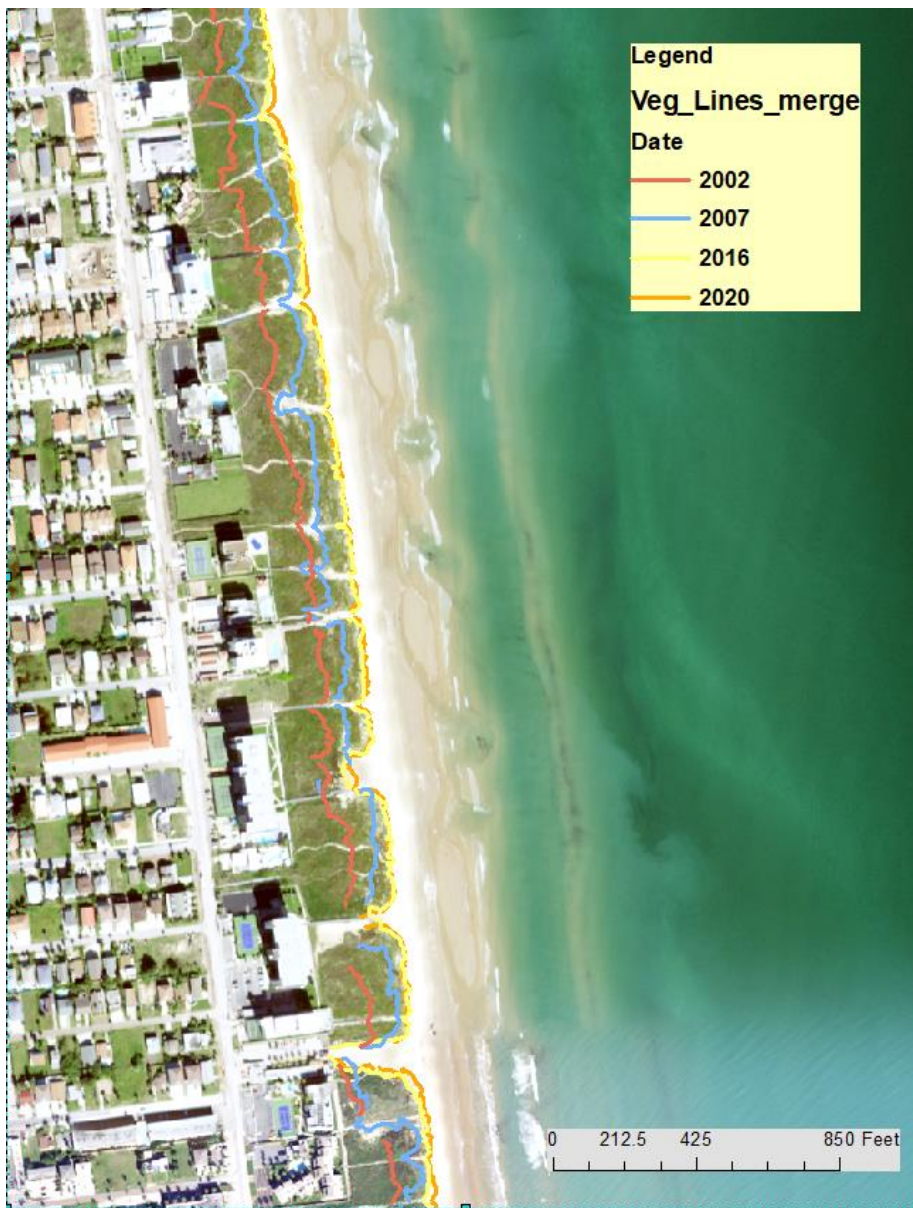
Figure 7. Portion of SPI that is representative of much of the study area in that the vegetated dune field has continued to prograde, becoming wider, over the time period of the analysis.

available) is relatively stable and consistently seaward of it's 2007 position (Figure 7). After the 2008 hurricanes, the City ramped up an effort to not only built and protect the beach and dunes but to develop a rigorous planting effort, adding thousands of specialty native dune plants to help stabilize the dune field and between 2012 and 2014 planted over 180,00 plants. These efforts have clearly had a major impact in holding the dune line and providing the City and oceanfront property added protection in the form of a healthy, wide dune field (Figure 8).

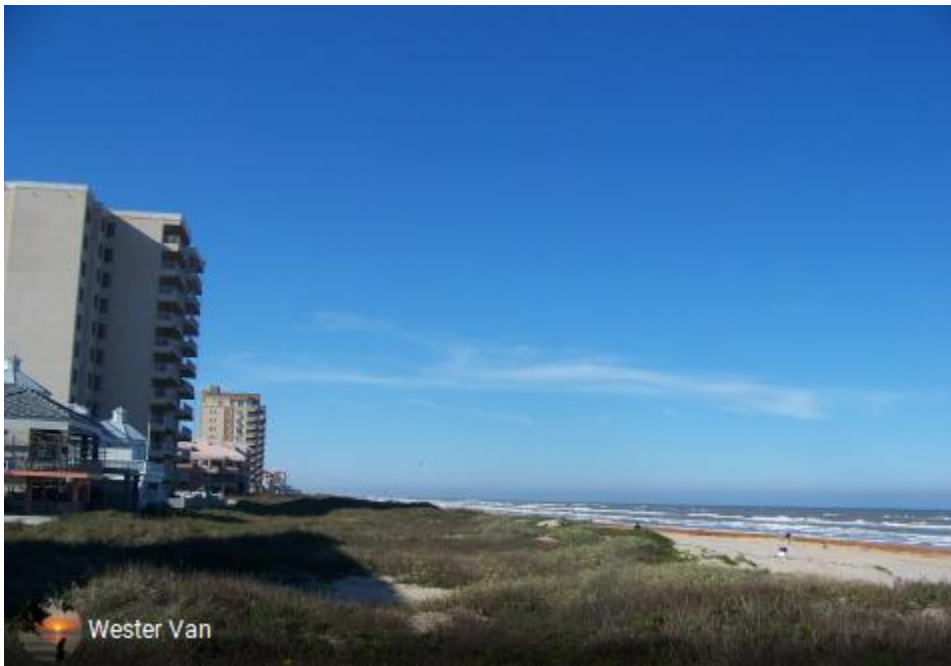
Figure 8. Photo from Google earth (credit: Wester Van) showing wide, well-vegetated dune field that presently exists at SPI.
