# EXISTING FACILITIES NEEDS ASSESSMENT FOR The South Padre Island Convention Center

For the  
City of South Padre Island, Texas  
June 1, 2012

rofa  
architects

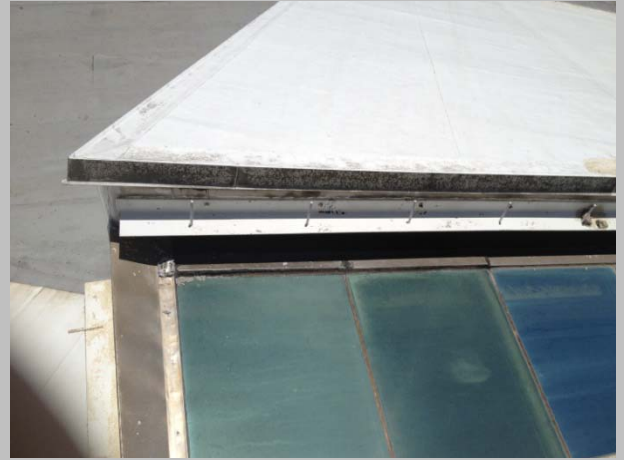
7. The storefront system located at the east lobby elevation consists of double-paned, glazed glass units meeting ANSI Z97.1 – 1984. This system does not meet the current standards set in IBC 2006 for Hurricane-Prone Regions. The same may be true for the louvers present at mechanical openings and the glazing at the canopy/main lobby skylight. (Photo #8 and #14)

**Photo #8** Gutter system at central canopy/main lobby skylight.

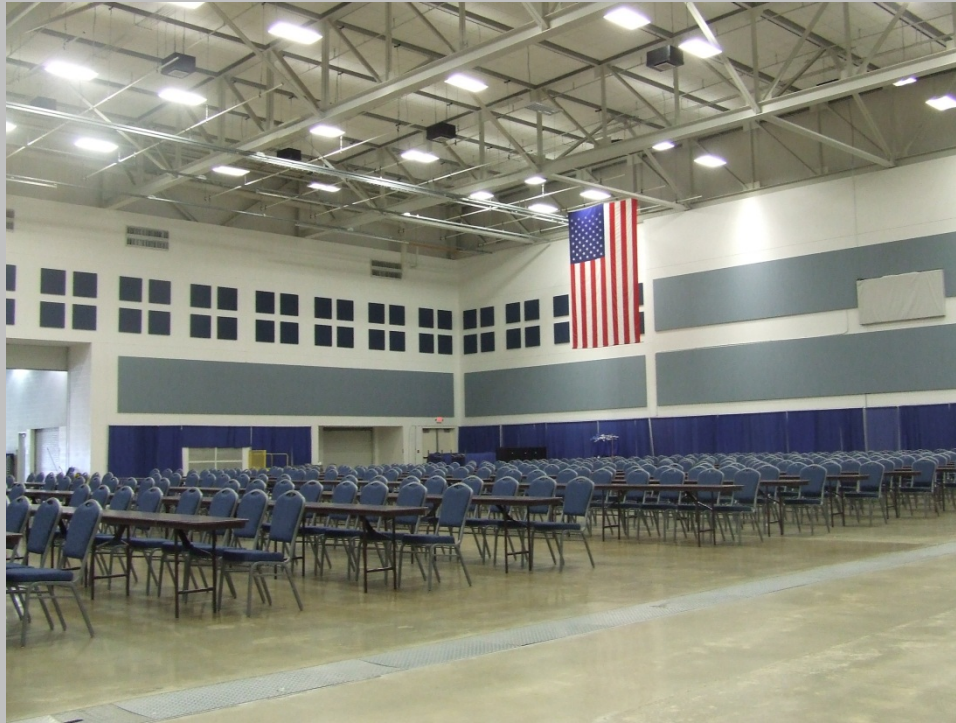
The majority of the interior lighting consists of linear fluorescent T8 and compact fluorescent lamps. The pendant-mounted down lights located in the main lobby utilize incandescent PAR lamps. The indirect lighting in the lobby utilize linear fluorescent T12 lamps. The lighting in the main ballroom consists of linear fluorescent T5HO, 6-lamp, high bay light fixtures in a 2x4 enclosure.

All linear fluorescent T12 lighting fixtures should be replaced with either T8 or T5 lamps since T12 lamps will no longer be manufactured in the near future, and they are less efficient. Incandescent down lights and pendant-mounted lighting fixtures should be replaced with more efficient compact fluorescent or LED lighting fixtures.

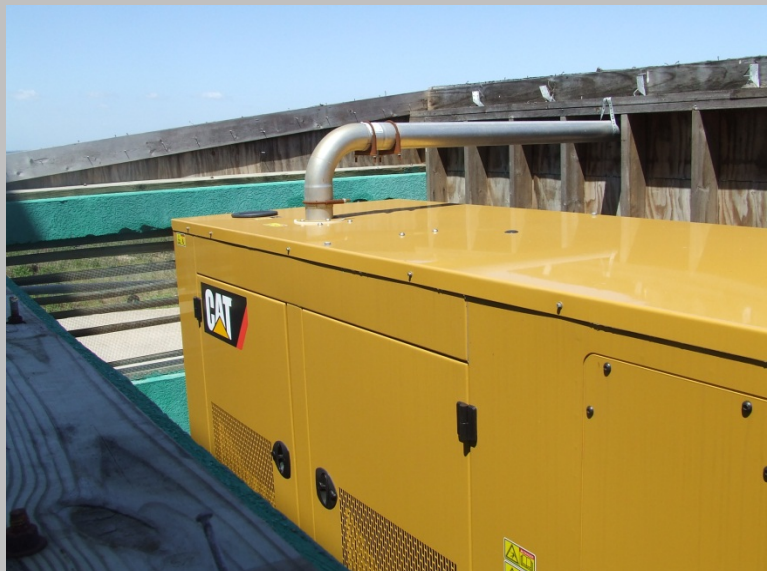
The emergency, stand-by diesel generator is rated for 125kW/156kVA at 480/277-Volts and was recently installed in 2012. It is installed in a weatherproof and sound attenuated enclosure, and it is located adjacent to the loading dock and main electrical room.

The generator is new and in great condition. If the generator's alternator windings were not coated with a marine epoxy sealant, the owner should contact the generator manufacturer to see if this coating can still be applied. This will prolong the life of the alternator. Space heaters should be installed inside of the generator's enclosure to reduce condensation if it was not initially provided with this accessory.

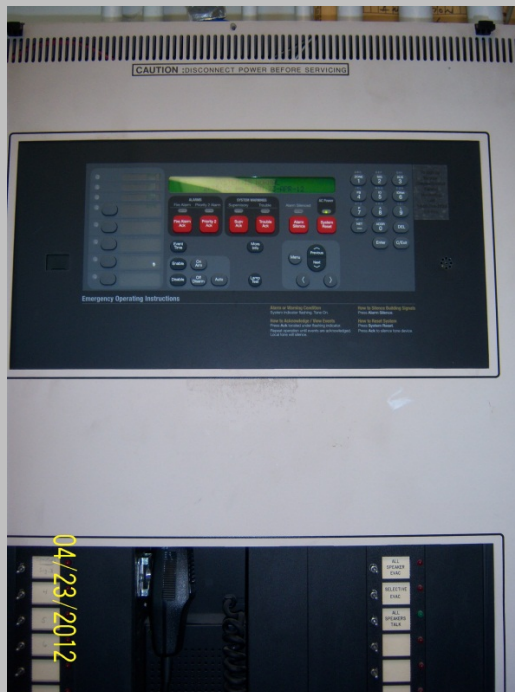
The existing fire alarm control panel is a Simplex model 4100. It is an addressable system with voice annunciation. This system has the capability of providing 1000 points of addressable input/output devices.

The fire alarm system is in good condition and does not need to be replaced.
